2025-2026 Field Mitigation Guide

This guide includes some potential issues which can occur with the 2025-2026 FIRST Tech Challenge competition field and the recommended mitigation measures field staff can take if they occur. The intent of this guide is to provide guidance to volunteers and events so they can ensure a fair and consistent experience for all competing teams.

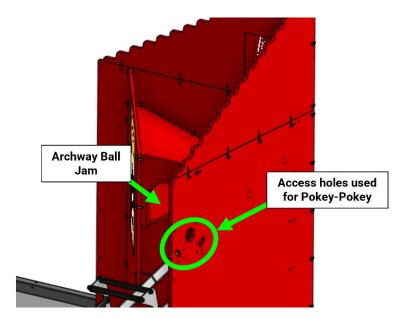
3: ARTIFACTS catch on the archway causing a bottleneck which plugs the GOAL.

This issue has not been able to be consistently reproduced during testing and seems to occur "randomly" at a low rate. If this issue repeatedly occurs on a specific FIELD, it is likely there is something wrong with the FIELD assembly.

Mitigation 3.1 – During a MATCH: Do not immediately stop the MATCH. If this jam is identified shortly after it occurs, FIELD STAFF (typically an FTA or their delegate) may clear the jam by physically "poking" the ARTIFACTS. They should use every effort to minimize impact to gameplay while clearing the jam. If necessary, a pen or short stick can be inserted through the access holes on the side of the GOAL closest to the archway (see diagram below). This is sometimes referred to as the "pokey-pokey" method.

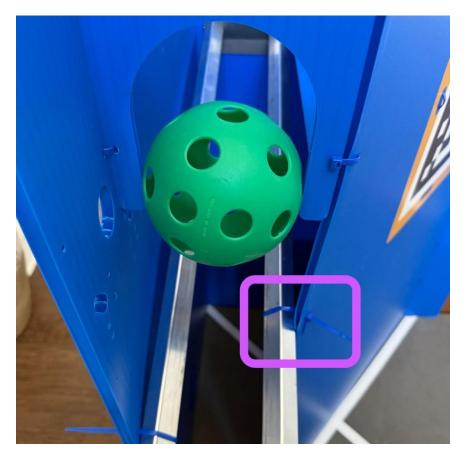
Mitigation 3.3: It is possible that when the cable tie shown below is over-tightened it can cause the archway to shift into an incorrect position or deform. If needed, replace/loosen the cable tie highlighted below.

Mitigation 3.4: It is also possible that this cable tie could be installed such that the cable tie head interferes with the ARTIFACT flow. If the cable tie head is in a position such that it can touch ARTIFACTS, it should be replaced or repositioned.

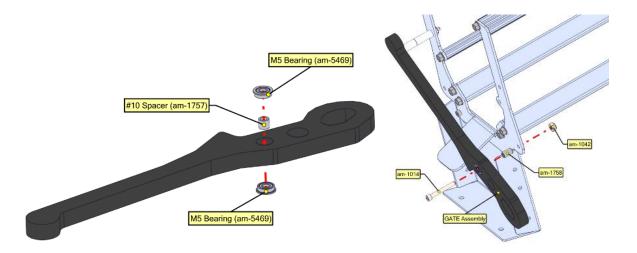
4: GATE does not close on its own and/or sticks in the upright "open" position.

Mitigation 4.3 – After a MATCH: Check whether the GATE freely rotates by hand. The GATE should move with very little friction. If there is friction, confirm the GATE is not rubbing anything during its movement (the only contact points should be the ball bearings pressed into the GATE arm which rotate around the pivot bolt). If there is no noticeable interference, but the GATE still has too much friction, next it is important to check that the components are assembled correctly and that the pivot screw is tightened correctly – if this is over-tight it can cause increased drag.

Next, check the bearings themselves to see if they spin freely or if they are damaged (make sure to check the full bearing rotation, since damage can occur in only one portion of the bearing.)
